Ninth Quarterly Report

Date of Report: *September 14, 2010*

Project Title: Effect of Concentration and Temperature of Ethanol in Fuel Blends on Microbial and Stress Corrosion Cracking of High-Strength Steels

Prepared by: Colorado School of Mines and National Institute of Standards and Technology

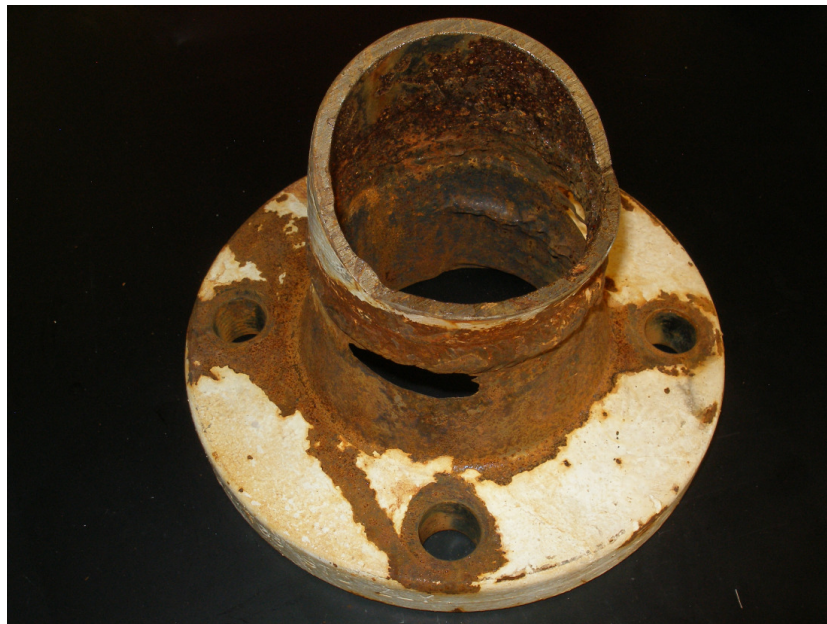
Figure 1 Corroded carbon steel pipe flange removed from the bottom of a failed ethanol spillage aboveground storage tank (AST) reported to smell like acetic acid. MIC by acetic acid bacteria is suspected to be the cause of the failure

After the failure, similar tanks were inspected and many were reported to smell like vinegar (acetic acid) and have a pH of around four. As microbes are known to produce acetic acid while using ethanol as a substrate, acetic acid producing microbes were presumed to be active in the ethanol spillage tanks and suspected to be responsible for the corrosion failure. Tank bottoms samples from the ethanol contact-water tanks were acquired. The microbial diversity of these samples was investigated with 16S rRNA gene sequencing. Preliminary results indicate that acetic acid bacteria grouping within the *Alphaproteobacteria* are the most abundant type of microbes in the tank bottoms of ethanol containment tanks [Figure 1]. These findings are consistent with previous findings regarding similar tanks at multiple locations suggesting acetic acid bacteria are present in environments associated with FGE. **Acetic acid bacteria fall under a category of microbes recognized to cause MIC known as acid producing bacteria (APB).** The environment possibly producing internal MIC in these USTs could simulate intermittent localized conditions experienced inside interstate pipelines transporting FGE. Periods of intermittent flow or pipeline downtimes could result in sections of the line exposed to stagnant water and contaminated FGE or ethanol fuel blends (EFB). During these times, microbial communities provided with ethanol fuel as a nutrient source, could flourish and produce organic acids and other harmful constituents damaging to the line. When normal pipeline operation continues, the microbes may become dormant but could quickly return with the onset of favorable conditions once again. Depending on the duration of these events, these conditions could compromise the integrity of the pipeline after a critical number of cycles.

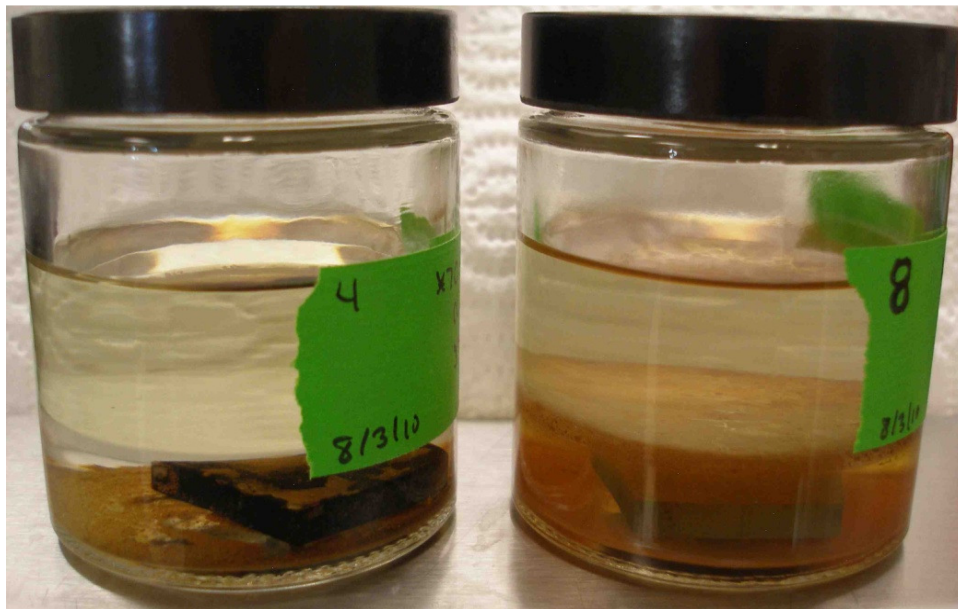
Figure 3 API X70 steel Coupons 4 and 8 immersed in the aqueous phase (lower layer) beneath the E10 fuel (upper layer). The jar on the left in Figure 3 is a sterile control. The jar on the right is inoculated with the tank bottoms sample. The microbial consortium in the tank bottoms sample is known to include acetic-acid-producing bacteria (APB) and possibly sulfate reducing bacteria (SRB)

Upon inspection of Jars 4 and 8, it was observed that a significant amount of debris was present at the interface of Sample 8 as shown above in Figure 3. Significant quantities of debris were also observed to be present on the bottom of the jar. The aqueous layer of Sample 8 appeared to be more turbid than Sample 4. Sample 4 was observed to be free of debris at the aqueous/organic interface and was observed to have less debris on the bottom of the jar. The corrosion on Coupon 4 was observed to be darker and less even than on Coupon 8. Coupon 8 was observed to have a thick even reddish coating of corrosion product. Closer inspection of the coupons after removal from the test cell revealed the presence of four large pits covered with black corrosion product as shown in Figure 4. Orange/brown as well as black deposits can be indicators of the activity of sulphate reducing bacteria SRB and/or iron oxidizing bacteria (IOB) (Blackburn 2004). The pits were broad, shallow, and had a stadium like morphology characteristic of MIC pits formed by a localized environment commonly produced by SRB. It should be noted that while pit morphology may be indicative of MIC, it should not be used as the sole indicator (Javaherdashti 2008).

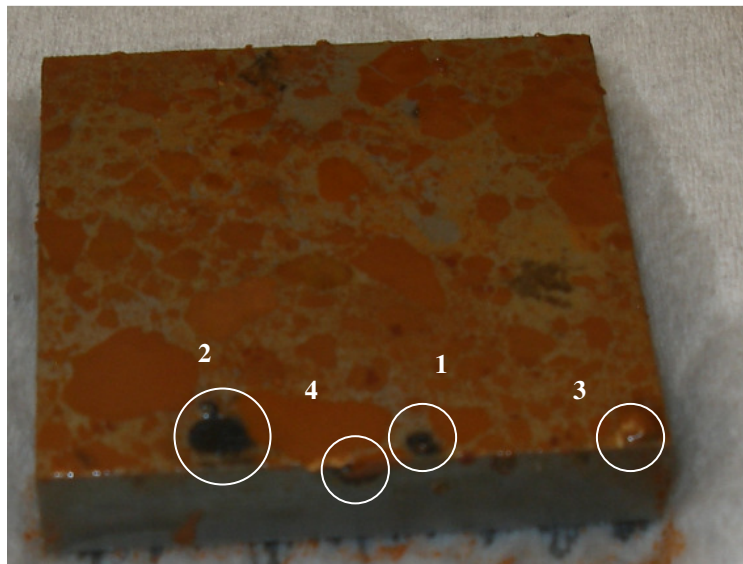
Figure 4 Photograph of pitted API X70 steel coupon (1 inch X 1 inch X 0.1875 inch) #8 removed from the aqueous volume of a two-phase system containing autoclaved creek water and filtered E10 fuel after 45 days of immersion displaying orange/brown corrosion product and four distinct corrosion pits (pre-washing)

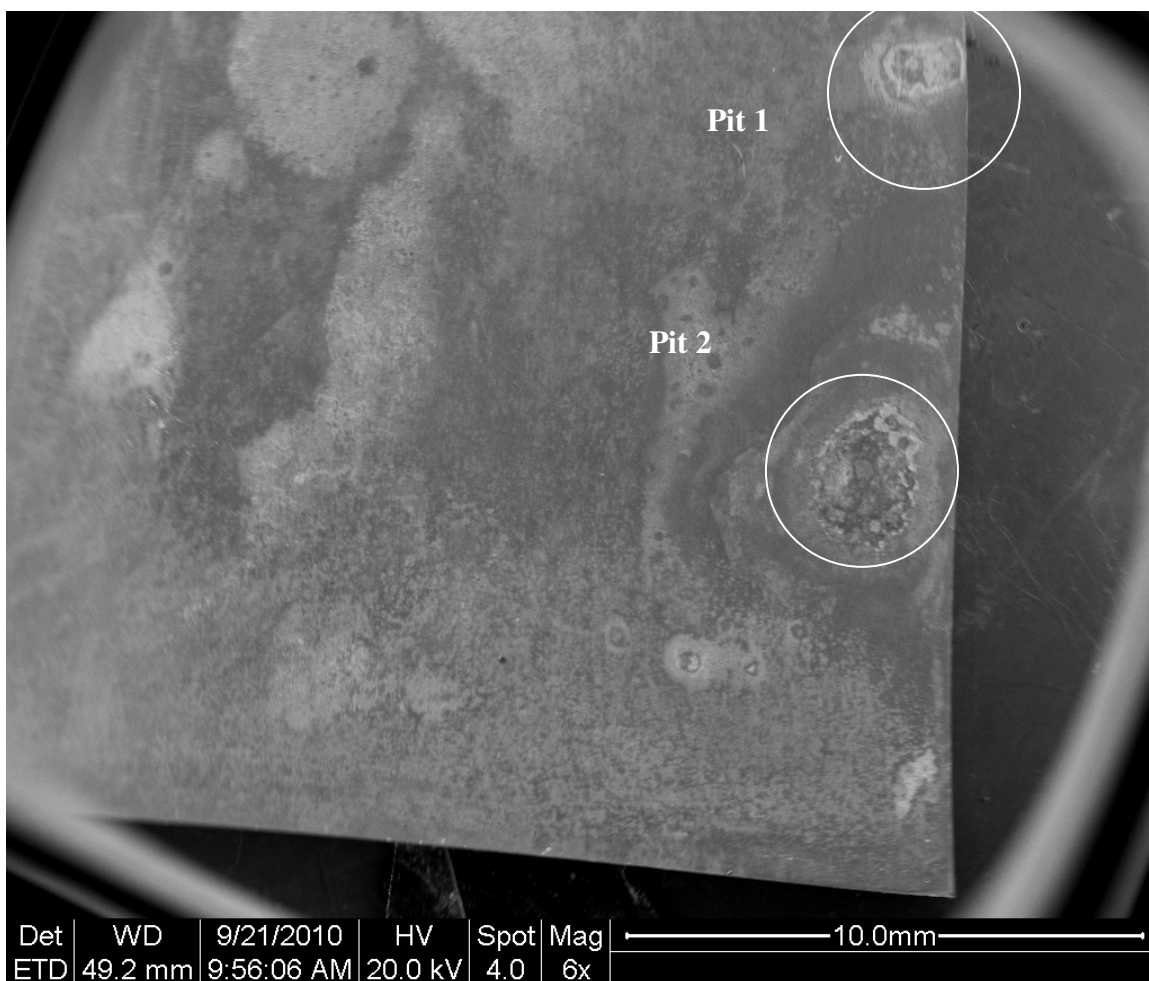
Figure 5 Environmental scanning electron microscopy (ESEM) micrograph of pitted API X70 steel coupon (1 inch X 1 inch X 0.1875 inch) #8 removed from the aqueous volume of a two-phase system containing autoclaved creek water and filtered E10 fuel after 45 days of immersion showing corrosion pits (6x)

The environmental scanning electron microscopy (ESEM) in Figure 5 shows pits 1 and 2 on X70 coupons 8. The ESEM image in Figure 6 shows a further magnified pit number 2 on X70 steel coupon eight. The entire pitted area partially covered by scale is depicted in the Figure. The area in the center of the pit still mostly covered with oxide is also indicated. Energy dispersive X-ray spectroscopy (EDS) was used for elemental analysis of locations in the pitted region. While EDS yields the elemental composition of the material, it does not give information about the bonding state (elemental form) or concentration of the elements present. EDS spot analysis was performed at several locations in the pitted area to search for elemental indicators of

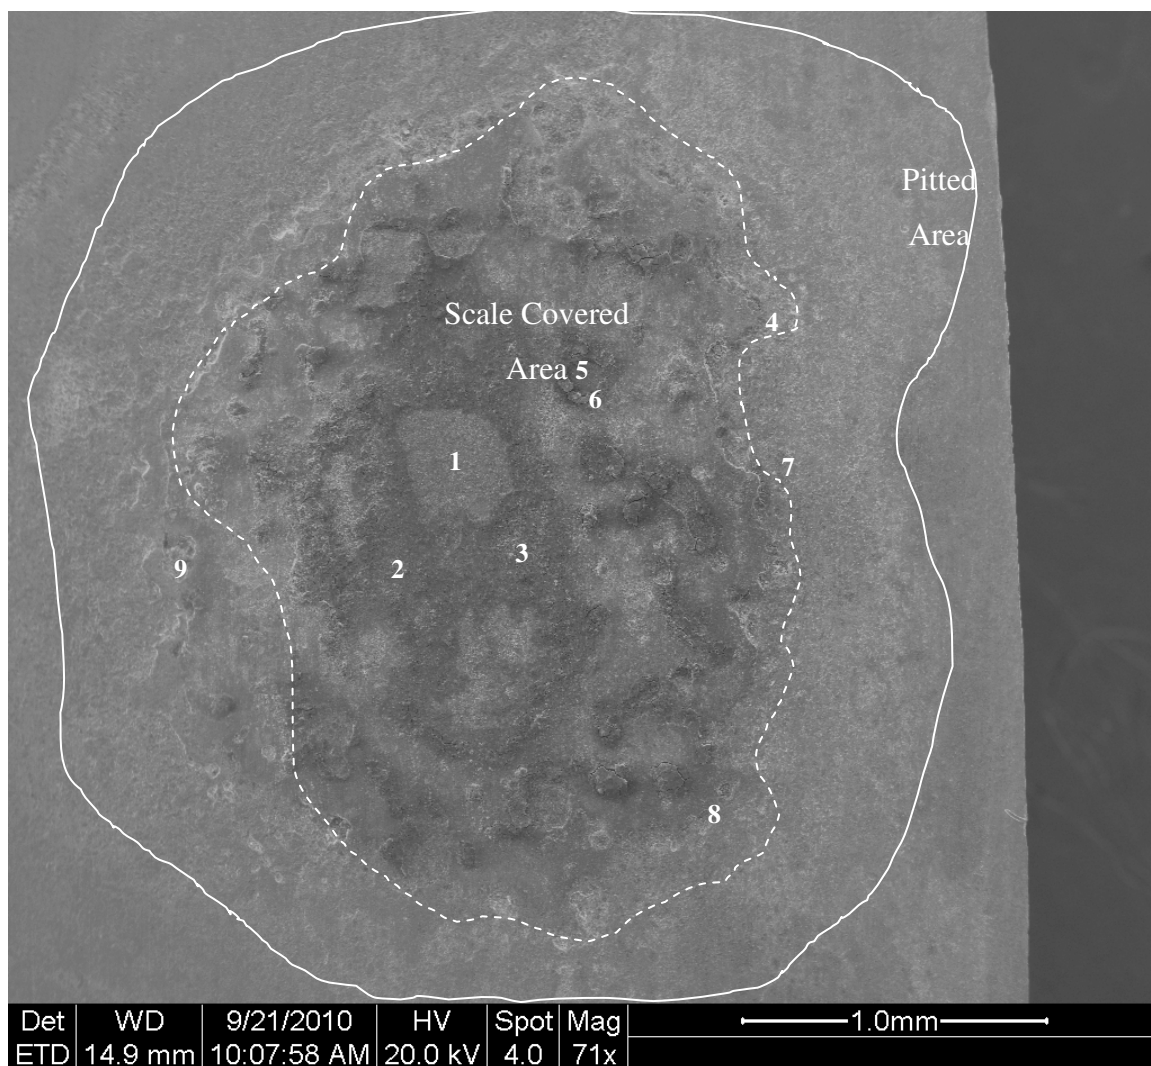
In the region of the pit where the oxide had been removed, EDS generated primary iron peaks collaborating with the visual observation that the oxide had been removed in this region exposing the metallic base of the pit. EDS spot analysis of the darker grey areas in the central region of the pit yielded strong iron and oxygen peaks confirming the presence of a relatively thick layer of iron oxide. Most interestingly, it was often the case that when EDS spot analysis was performed at locations near the border of the oxide covering (locations 4, 7, 8, 9), the presence of sulphur and carbon was more pronounced. Sulphur is of interest as sulphate-reducing bacteria (SRB) are known to metabolize sulfates by reducing them to sulphide. The resulting sulfide can be found deposited on the surface of the corrosion site in the form of iron sulphide. Carbon signals were also observed to be present in the EDS spectra that demonstrated the presence of sulphur. These peaks may also suggest the presence of organic material (e.g. extracellular polymeric substance, microbial cells) and corresponding microbes at the corrosion site. The size of the peaks appeared to be somewhat proportional with larger sulphur peaks corresponding to larger carbon peaks.

Figure 6 Environmental scanning electron microscopy (ESEM) image of pit number 2 with pitted area bounded by a solid white line, the area of general scale cover bounded by a dashed white line, and numbered energy dispersive X-ray spectroscopy (EDS) spot analysis locations (1-9) (71x)

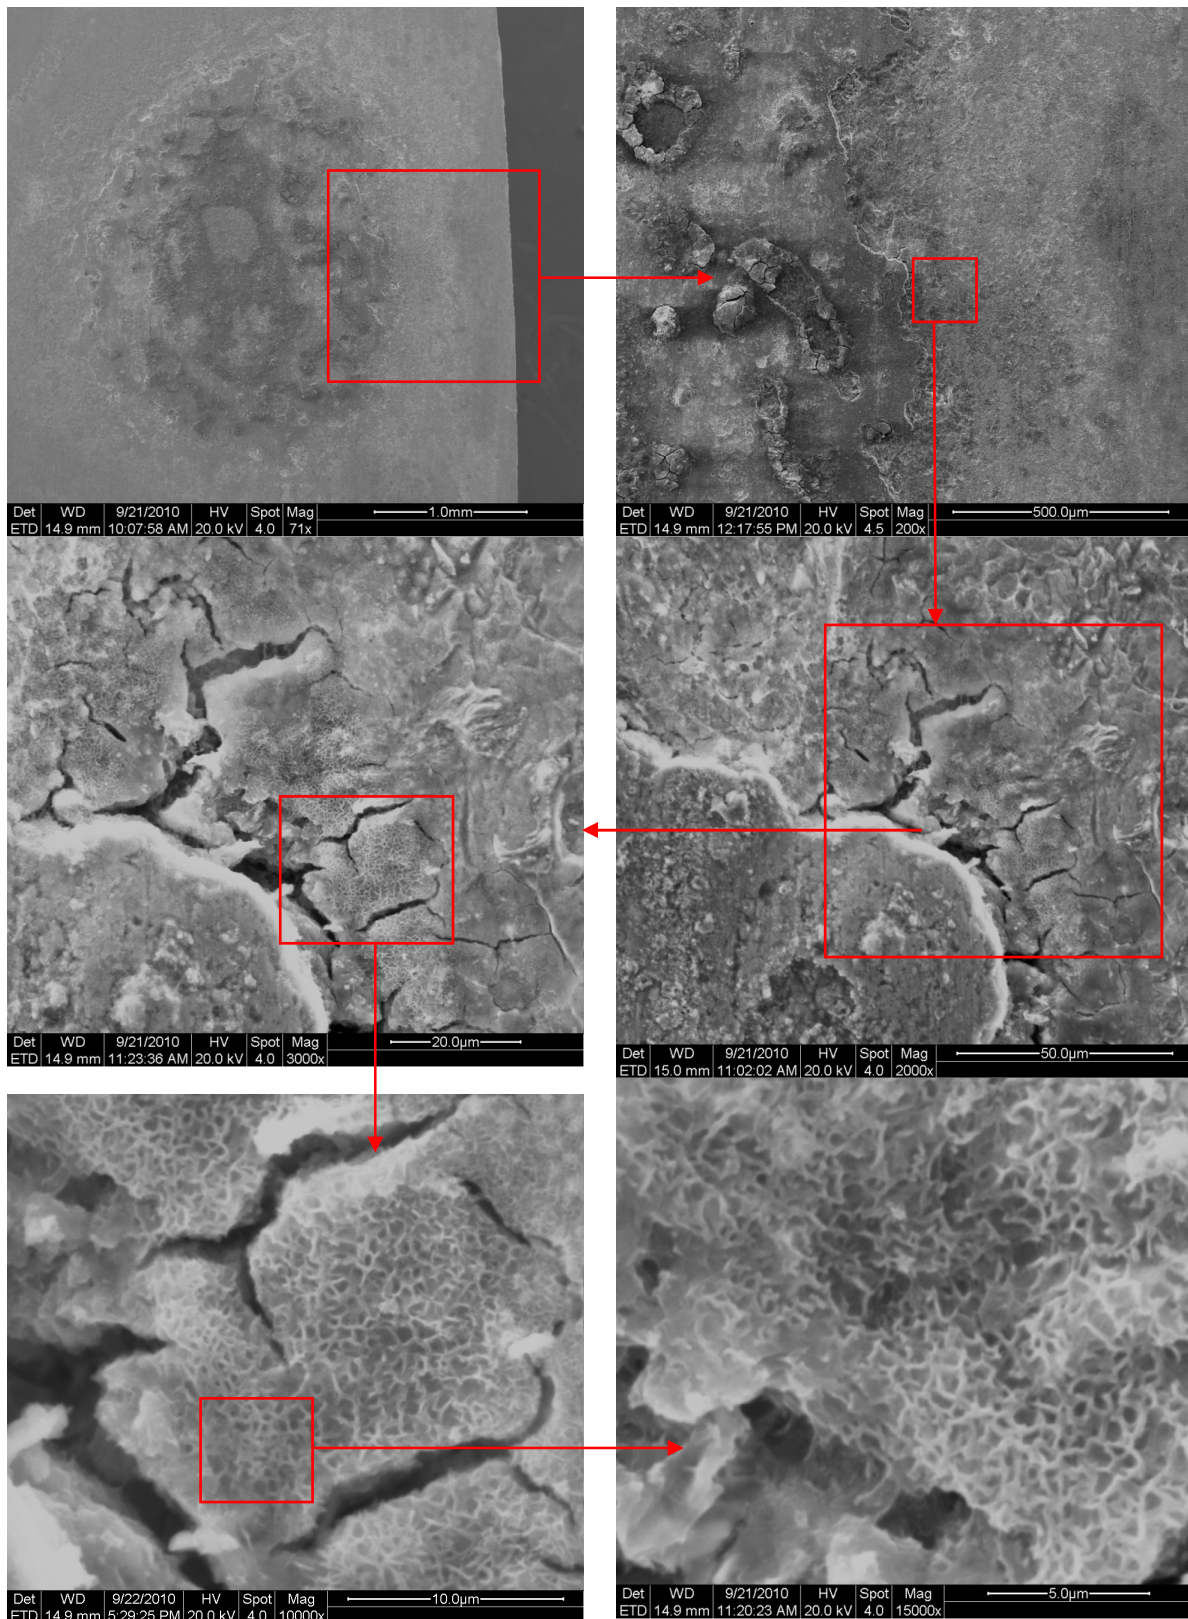
Figure 12 ESEM imaging of location seven on pit two using varying magnifications

Due to the presence of large sulphur and carbon peaks found at location 7 in pit 2, a more detailed investigation was performed in that area. Several ESEM micrographs were acquired of the area at different magnifications as shown below in Figure 12. The area is located to the right of the center of the pit approximately one half of the distance to the outer rim. This area is also observed to be approximately where the scale covering over the pit base ends. Upon closer observation, morphology can be observed which does not appear to be typical of an inorganic structure likely to be found at a sight of steel corrosion.

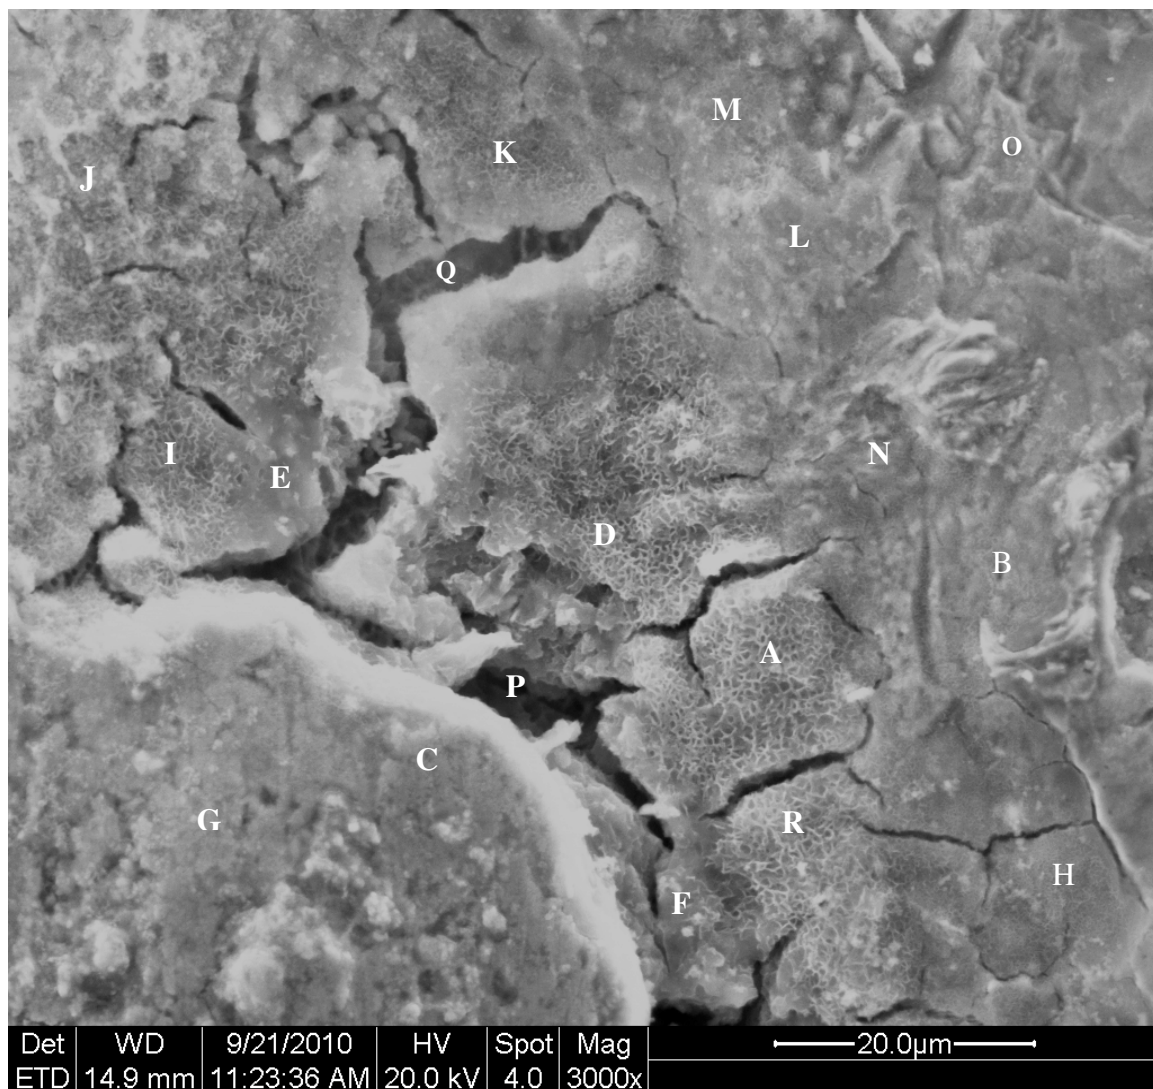
The EDS spot analysis of location 7 on pit 2 was performed at high magnification at locations 7A-7R defined below in Figure 13. The EDS analysis of locations in the lower right corner of the image (7G and 7C) yielded strong iron and oxygen peaks indicating the prevalence of iron oxide. The analysis confirms that the center of the pit is largely covered in iron oxide. The EDS analysis of locations on the right side and upper right corner of the image depicted only large iron peaks indicating metallic iron. These results confirm that the outer edges of the pit the exposed pit bottom. The EDS spot analysis of locations (A, D, E, F, I, J) coinciding with the fibrous feature yields relatively strong sulphur and carbon signals compared with the surrounding surface. This information reinforces the possibility that the feature could be organic and associated with organisms utilizing sulphur species.

Figure 13 SEM image at 20 kV of location 7 on pit 2 on an API X70 steel coupon (3000x)

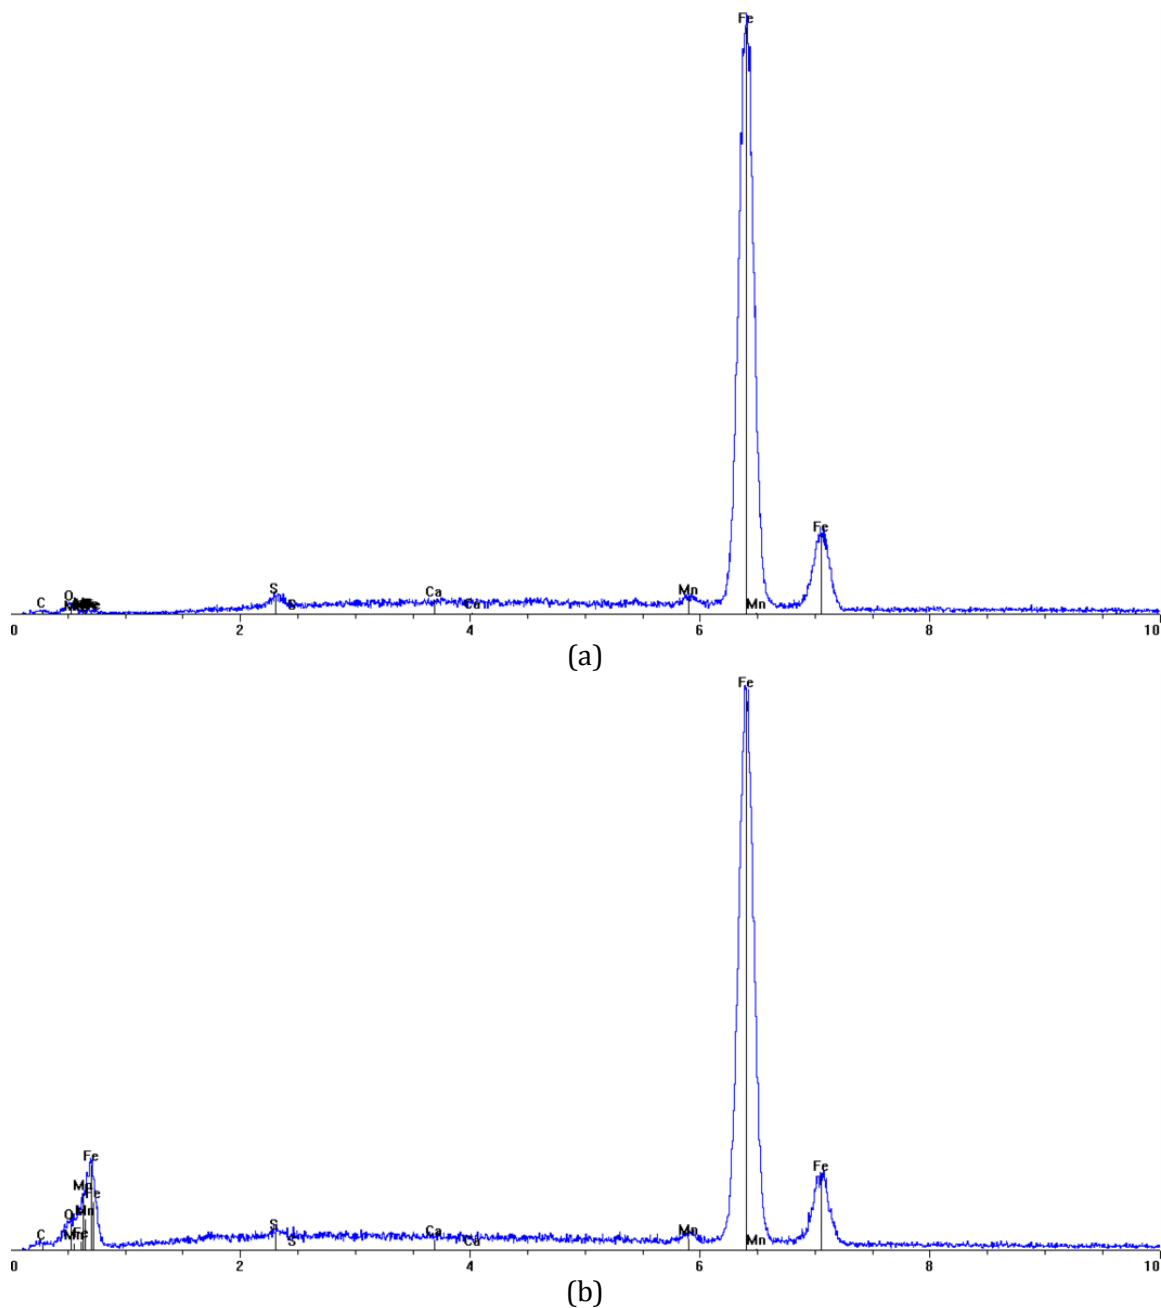
Locations P and Q represent areas where deep cracks appear to penetrate the surface. The EDS spot analysis in the cracks indicate the prevalence of metallic iron suggesting that the cracks penetrate into the underlying steel surface thereby exposing new surface for corrosive attack. These results may indicate microbial attack and resulting chemical dissolution, possibly along grain boundaries.

Figure 19 Energy dispersive X-ray spectroscopy (EDS) spot analysis at 20 kV depicting strong iron peaks indicating predominately metallic iron with smaller amounts of oxides, sulphur, and manganese species of an API X70 steel coupon at locations in area “7” (Figure 13) (a) “P” and (b) “Q”

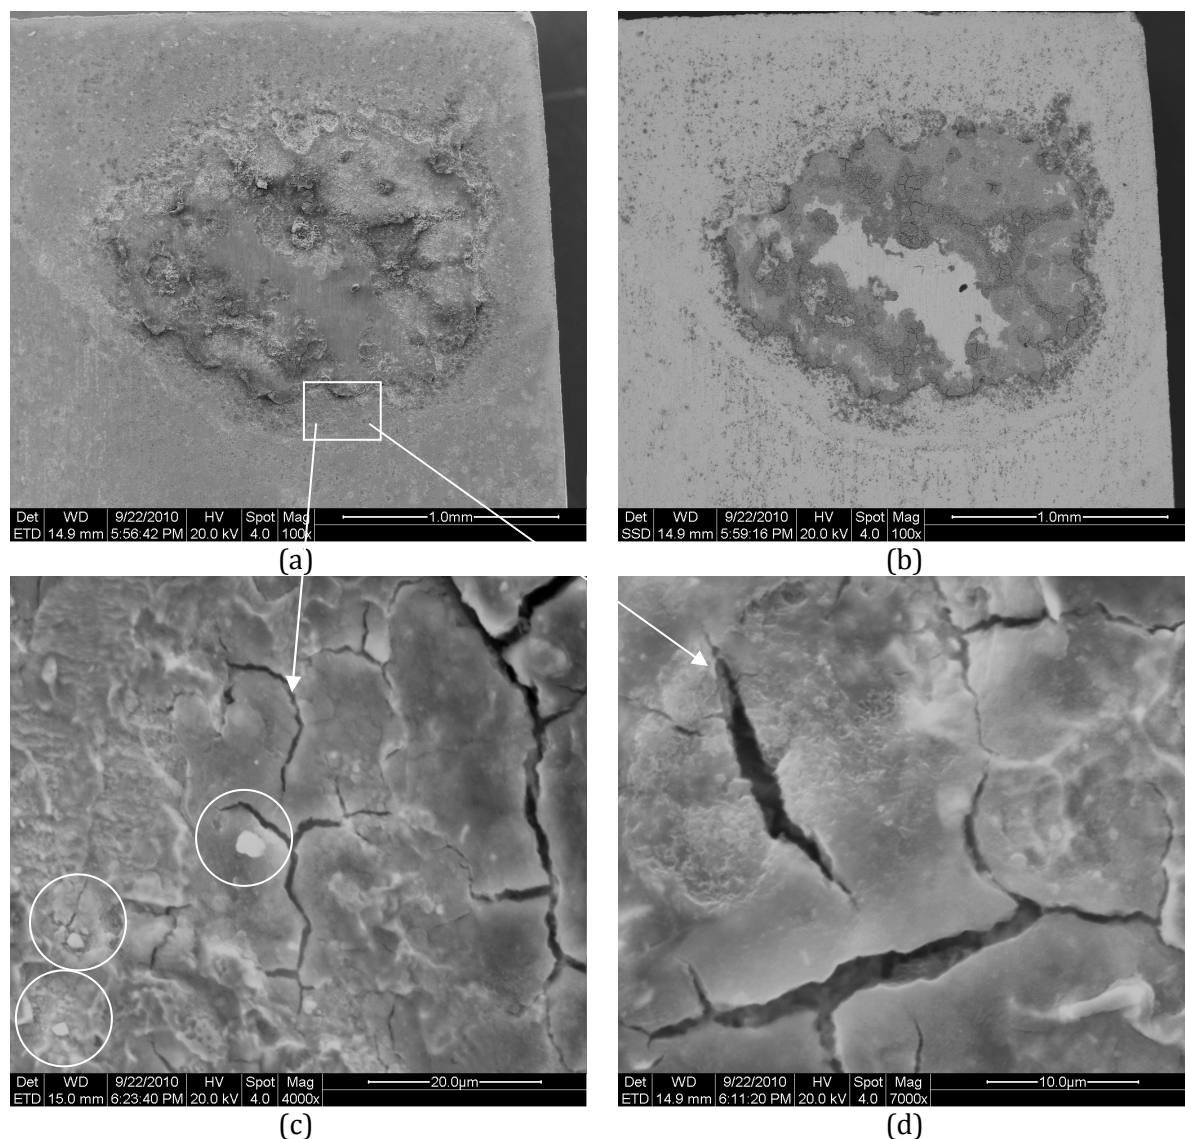
Figure 20 Environmental scanning electron microscopy (ESEM) micrographs of pit 2 on API X70 steel coupon (1 inch X 1 inch X 0.1875 inch) number 8 showing (a) a secondary electron image of the pit (100x) (b) back-scattered electron (BSE) image of the pit (100x) (c) a calcium deposit as identified with energy dispersive X-ray spectroscopy (4000x) (EDS) at 20kV (d) localized surface irregularity corresponding to the presence of sulphur and calcium as identified by EDS (7000x)

ESEM micrographs were taken and EDS spot analysis was performed on pit 2 on API X70 coupon 8 [Figure 20a, b]. Of particular significance was the discovery of relatively large calcium deposits [Figure 20c] found near regions of localized pitting and attack [Figure 20d].

These regions of interest were also located around the edge of the intact scale on the bottom of the pit.

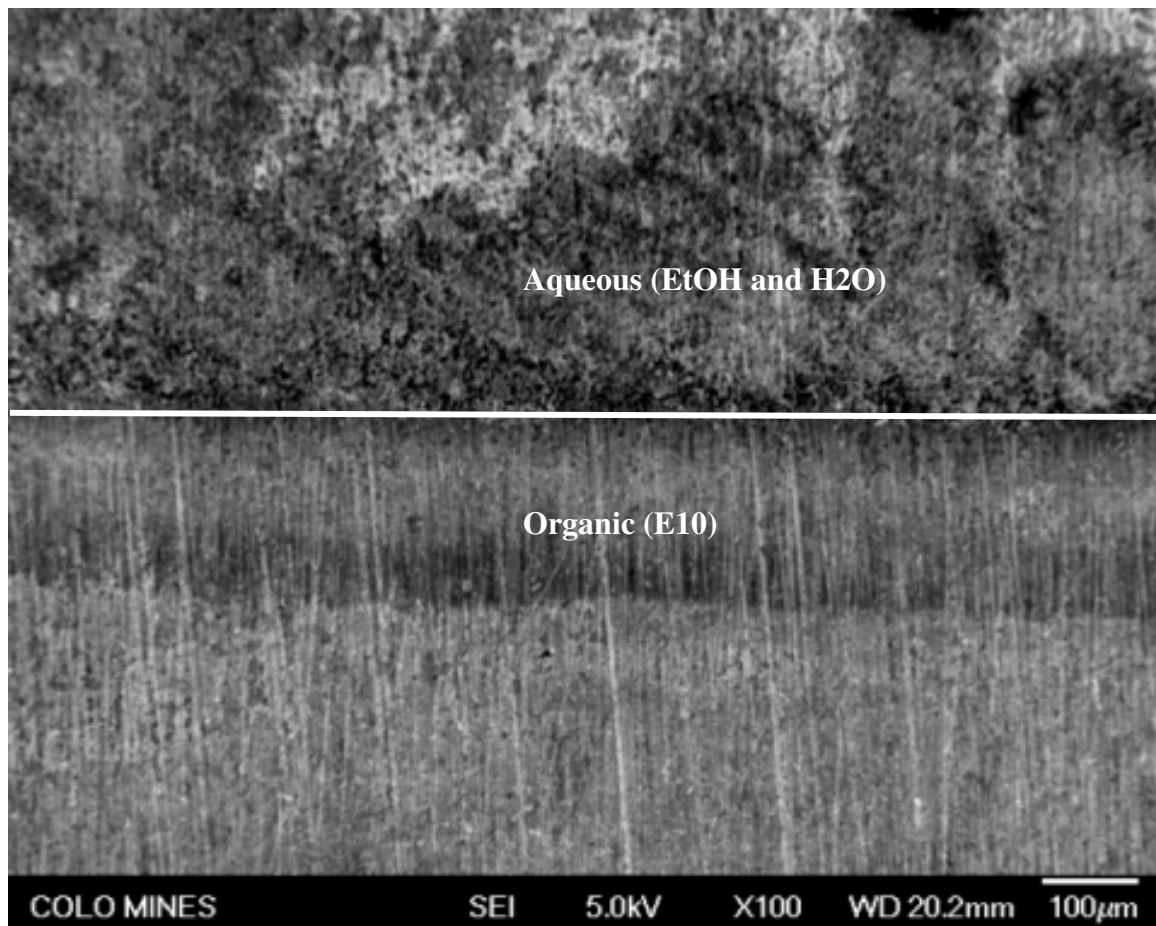
Immersion testing was performed on ASTM A36 carbon steel specimens after adding water in the range mentioned above. Field emission scanning electron microscopy (FESEM) measurements were performed on the specimens after seven days of immersion. Figure 22 shows the micrograph of an ASTM A36 carbon steel coupon at 100x magnification after being immersed in gasoline-ethanol and water-ethanol phases for seven days. The top half portion of the micrograph representing the water-ethanol phase exhibits extensive corrosion while the bottom half portion of the micrograph representing the gasoline-ethanol phase displays a corrosion-free surface. The extent of corrosion was found to be the greatest near the interface in the water-ethanol phase.

Figure 22 Field emission scanning electron microscopy (FESEM) micrograph of an ASTM A36 steel coupon magnification after being immersed in gasoline-ethanol and water-ethanol phases for seven days (100x)
